\_\_\_\_\_ \* General Inventory - 763 (e)(1)

Name of School Fairland Cntr.

Address: 13313 Old Columbia Pike  
Silver Spring, MD 20904

# AHERA Form B; Assessment and Response Action Table

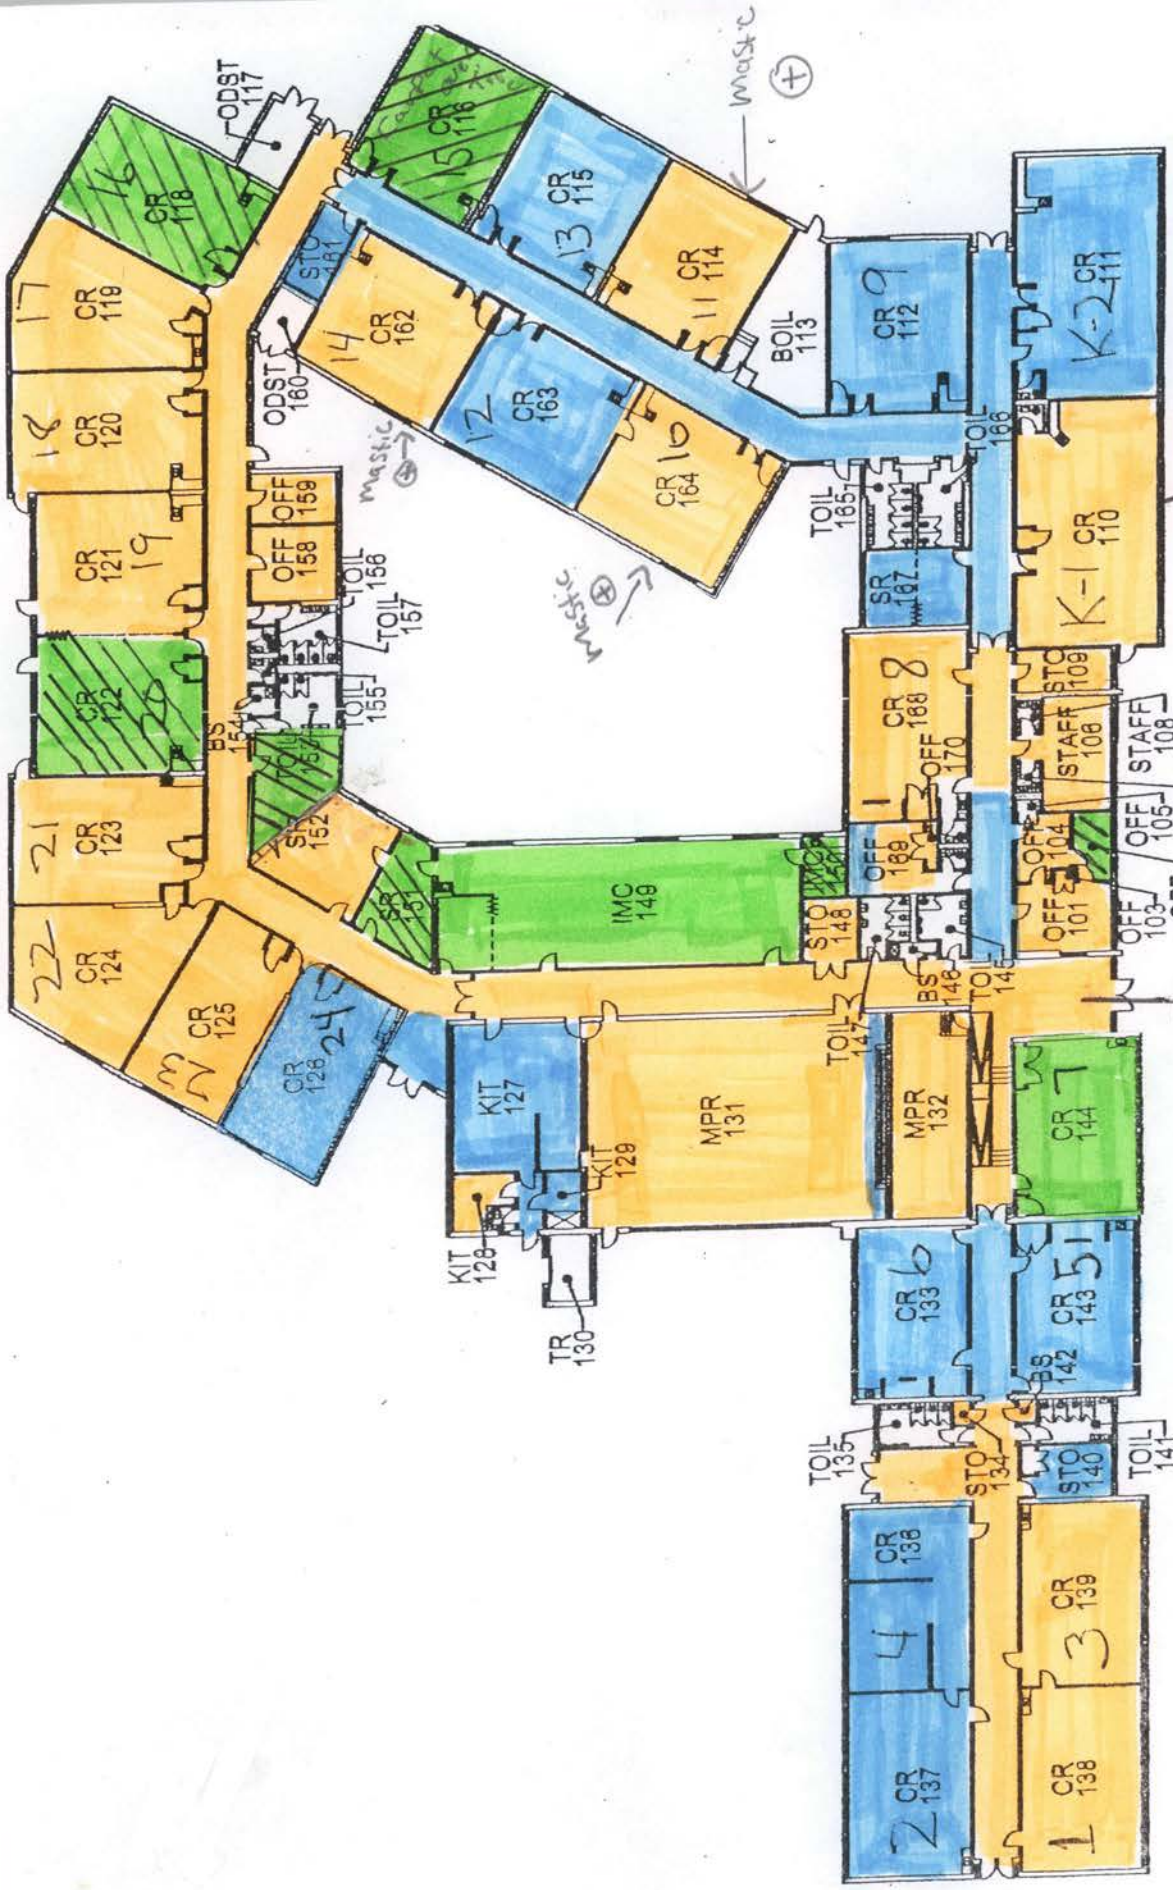
MAIN FLOOR PLAN

Floor tile

Double tile

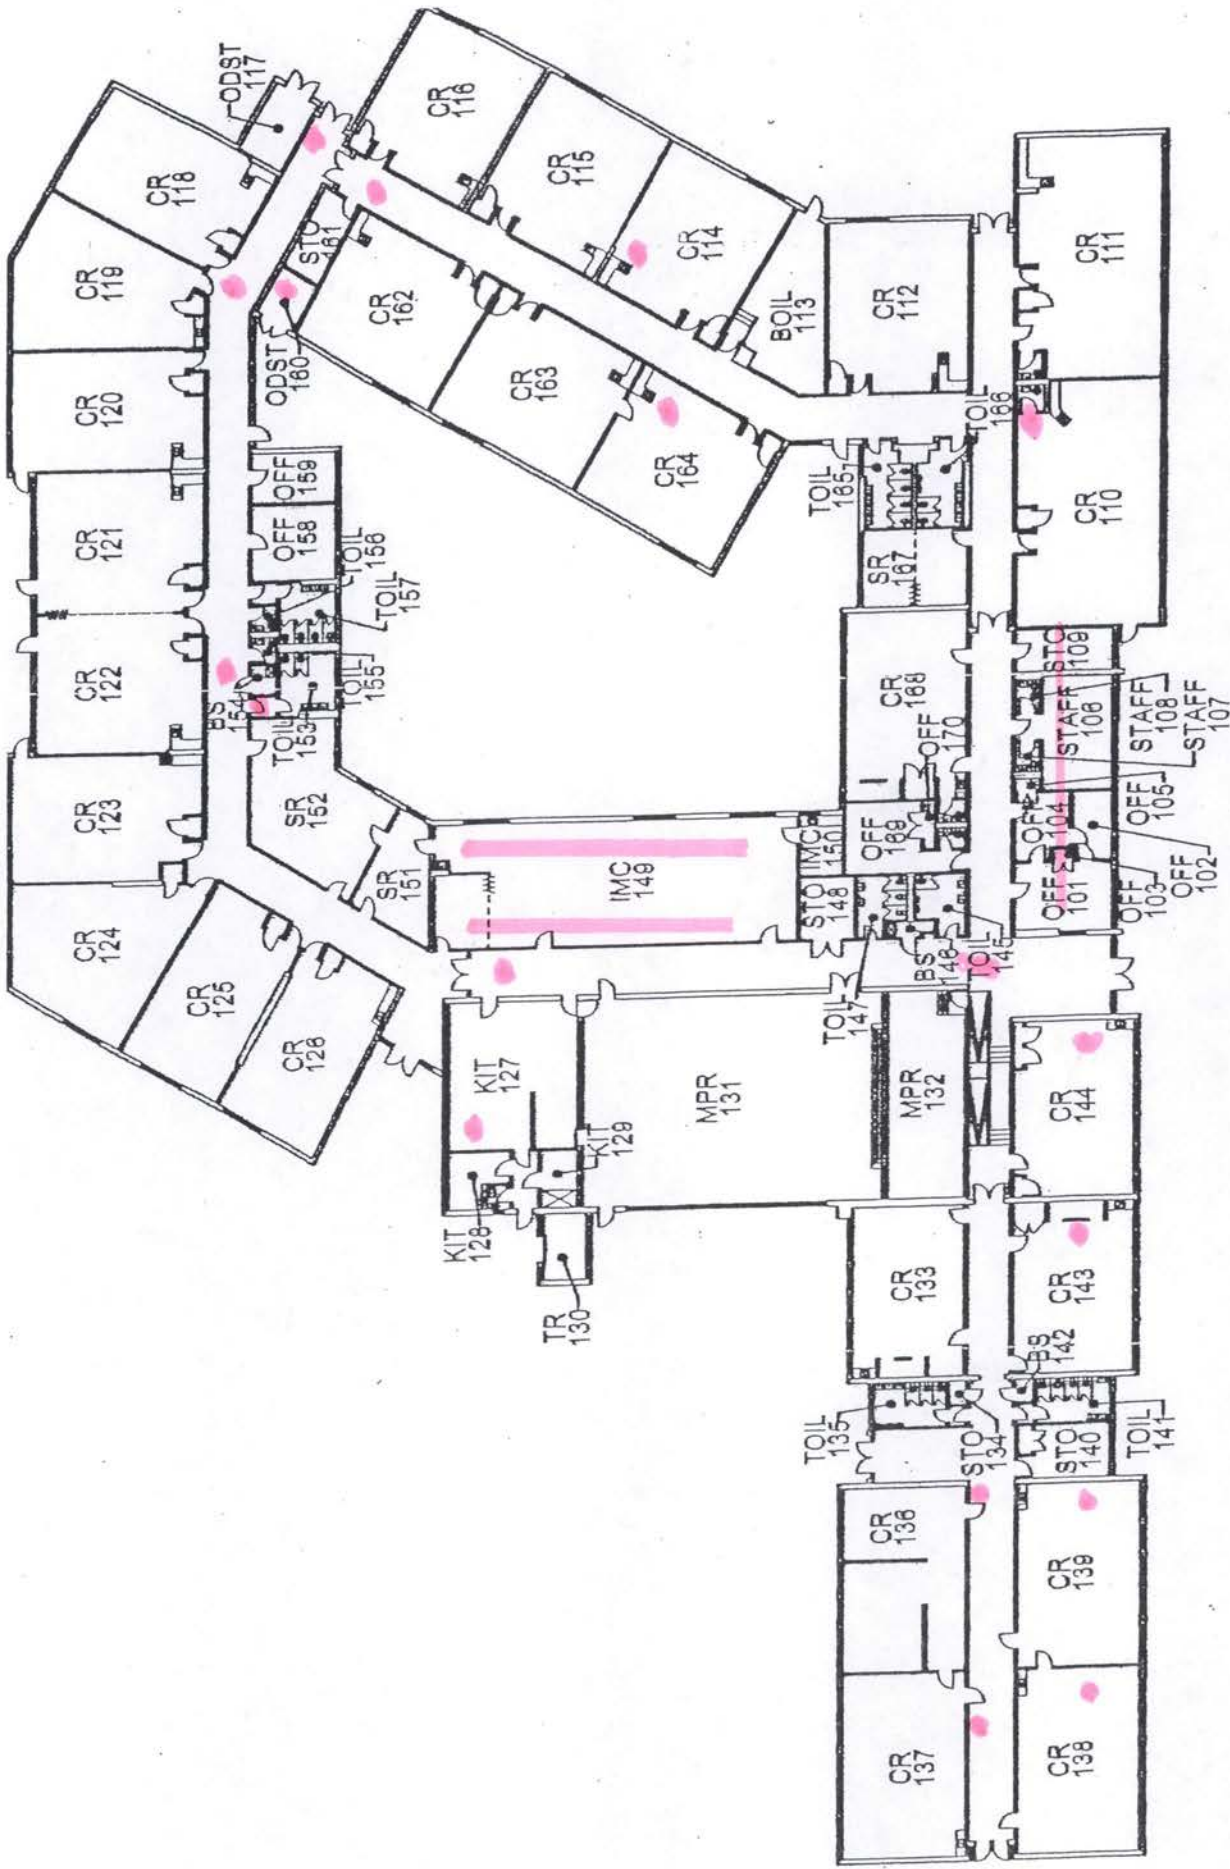
MAIN FLOOR PLAN

● — mod joints  
 Black mastic on duct &  
 Pipe ⊕

Drain Pipe Location

If drain pipes are  
modded assume ⊕  
Not visible from  
inside.

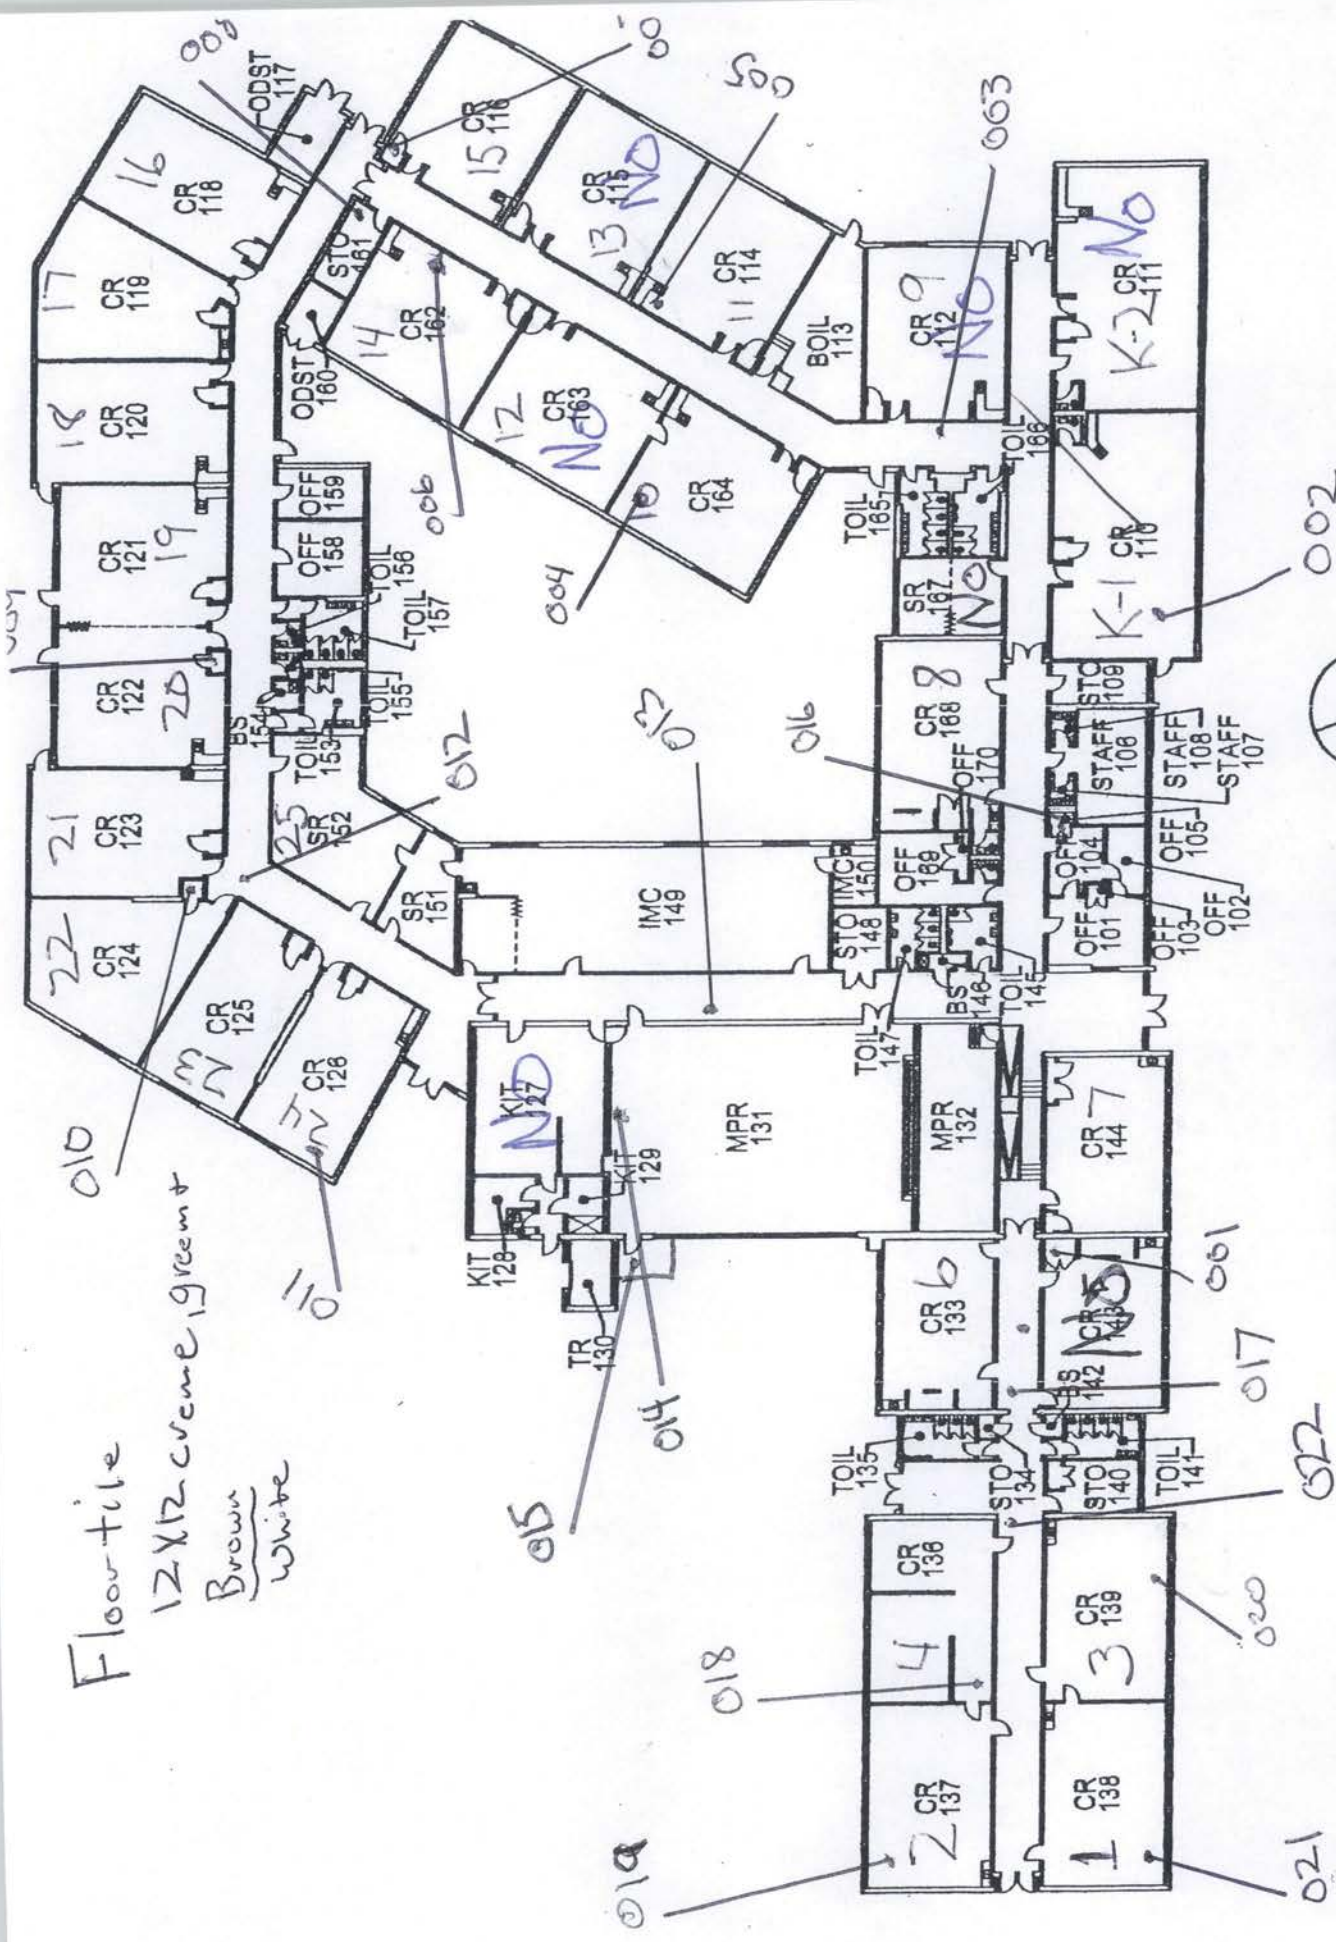
Floor tile  
 12x12 cream, green +  
 Brown  
 White
