\_\_\_\_\_ \* General Inventory - 763 (e)(1)

Name of School Fairland Cntr.

Address: 13313 Old Columbia Pike  
Silver Spring, MD 20904

# AHERA Form B; Assessment and Response Action Table

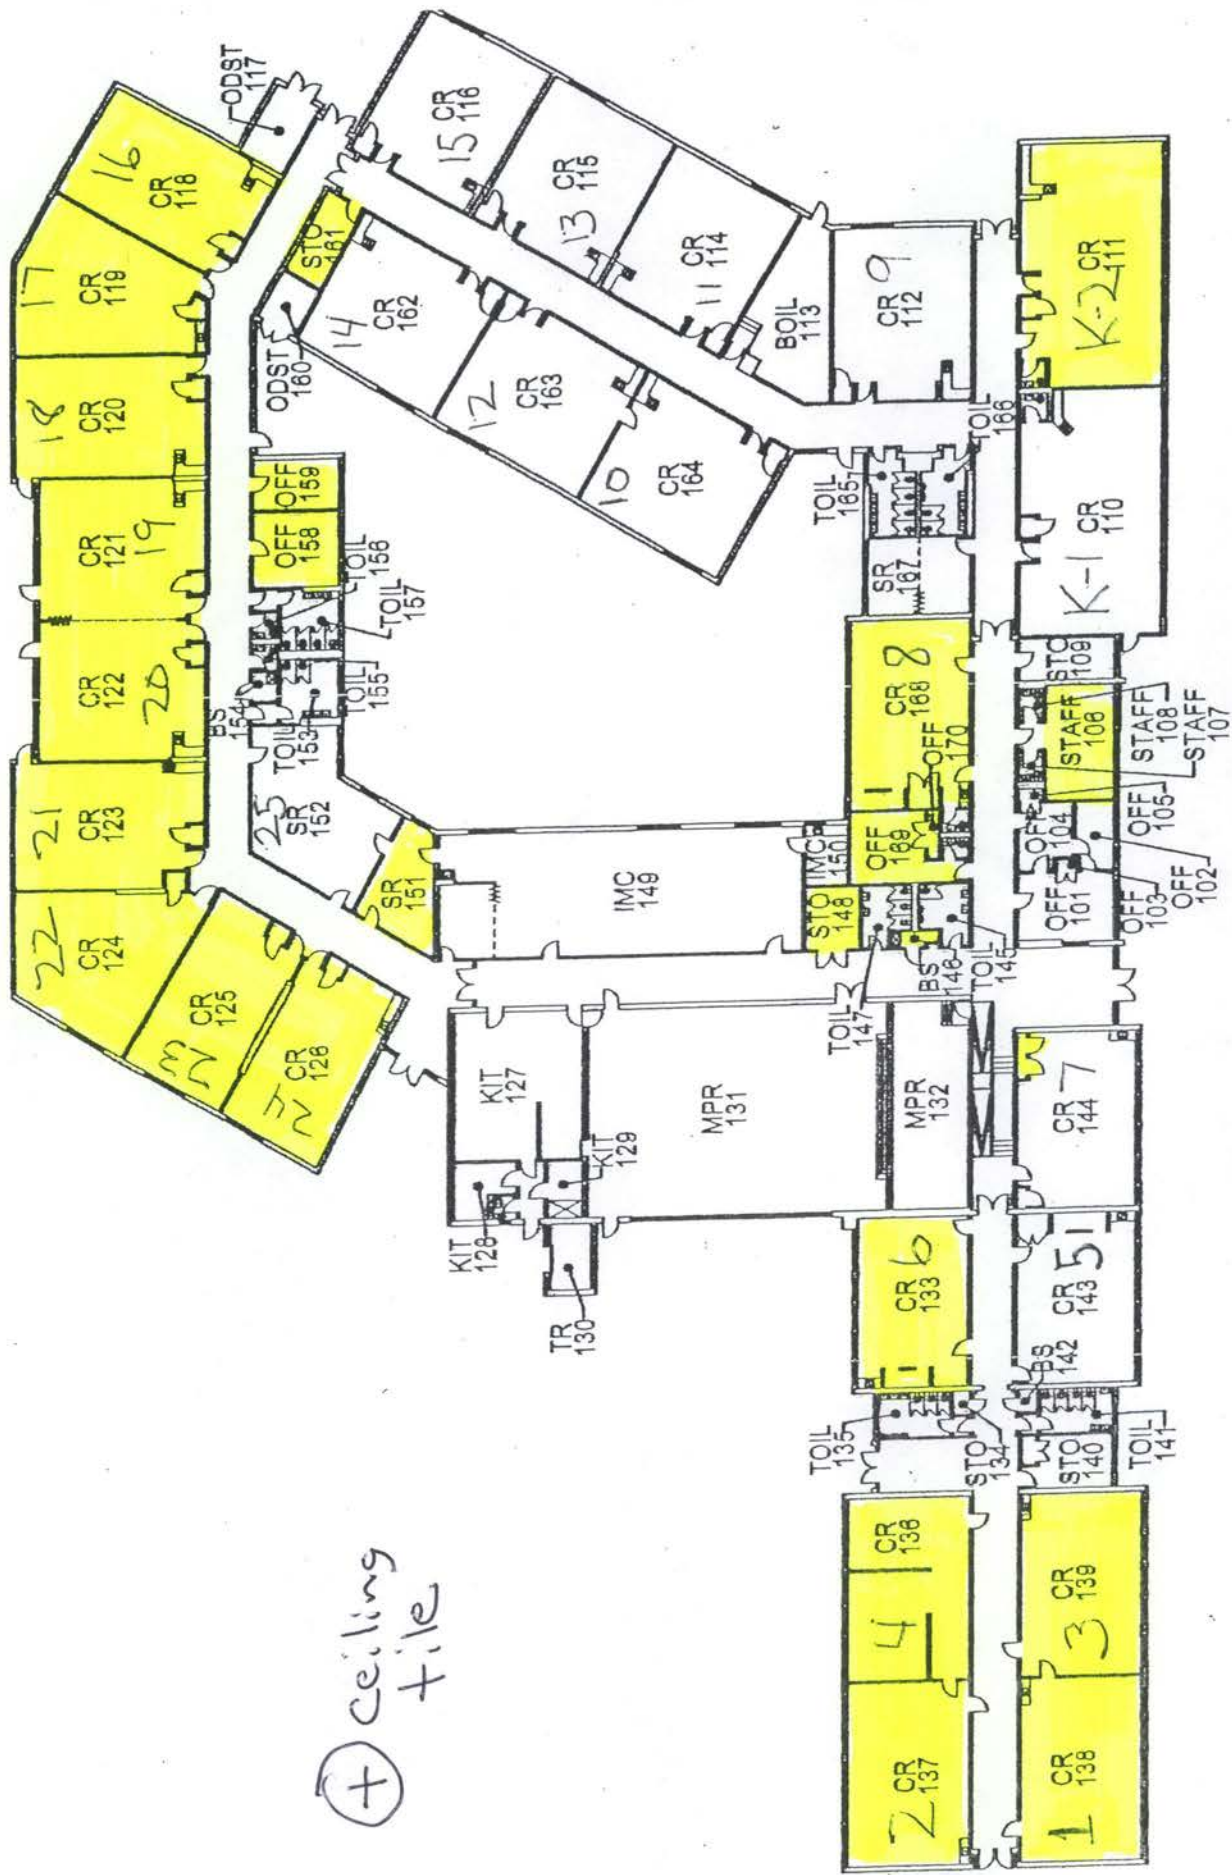
MAIN FLOOR PLAN

Double tile

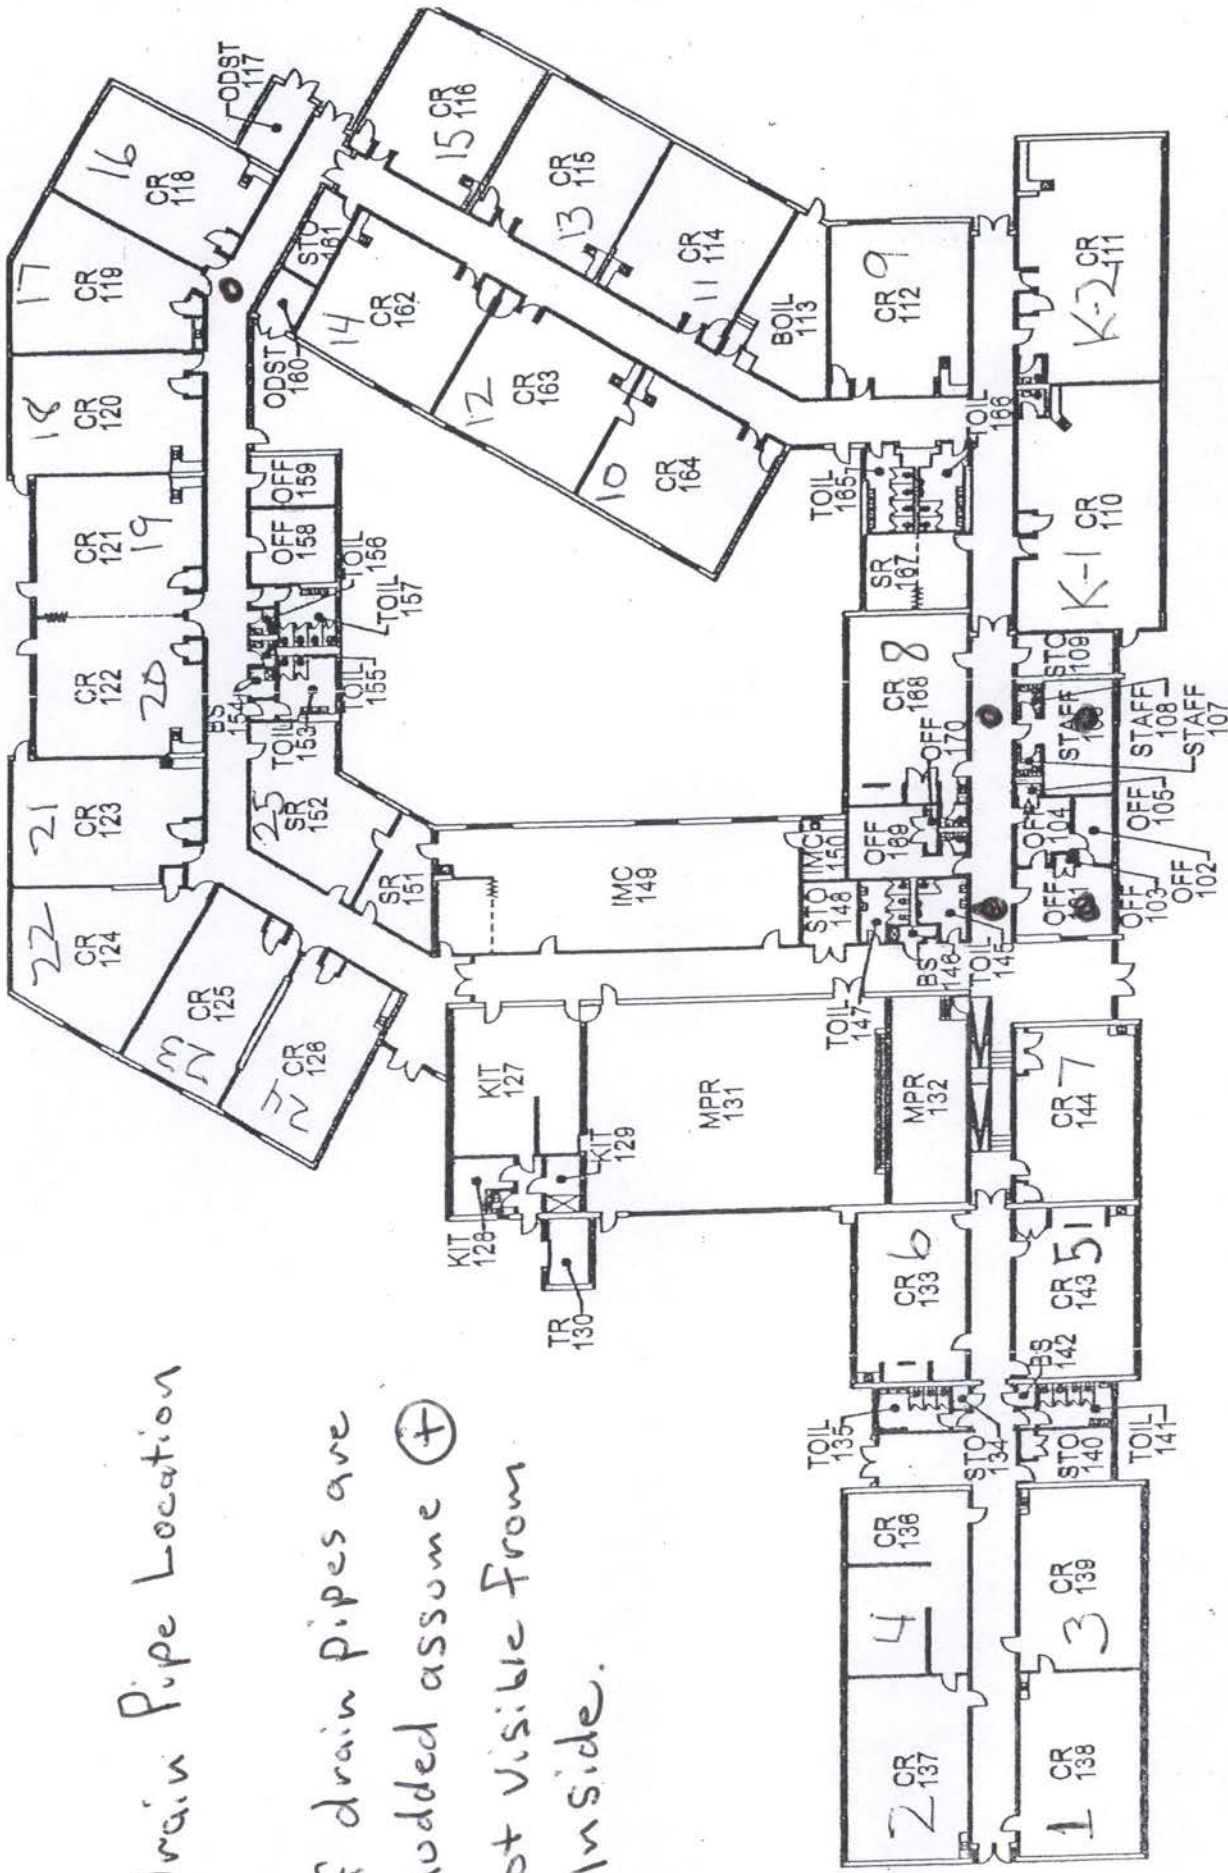
MAIN FLOOR PLAN

● — mod joints  
 Black mastic on duct &  
 Pipe ⊕

Drain Pipe Location

If drain pipes are  
modded assume ⊕  
Not visible from  
inside.
